# Beautification of Taladanda Canal using CCGM Lining Technology in Cuttack Millennium City

from RD00 to 1.5Km

BEATUFICATION OF TALADANDA CANAL USING CGCM LINNING FROM RD 0.00 TO 1.5KM

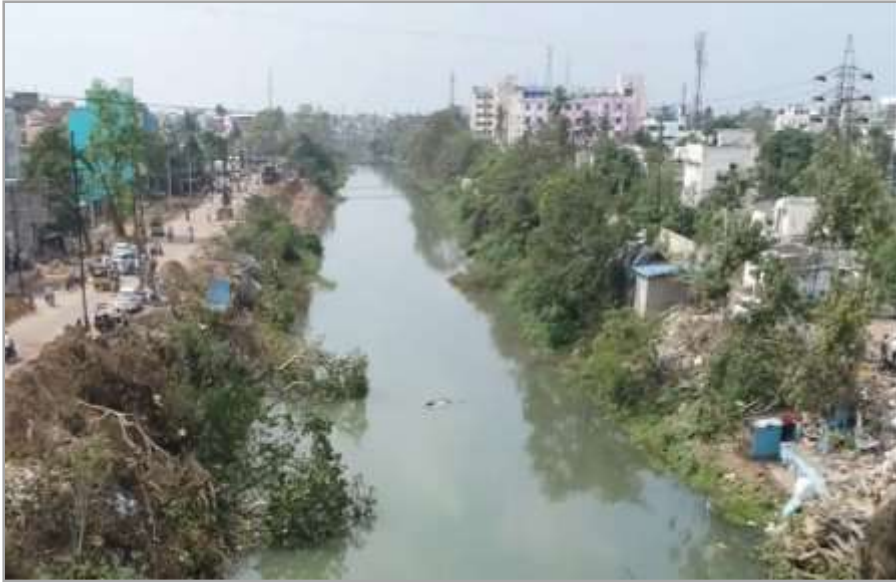
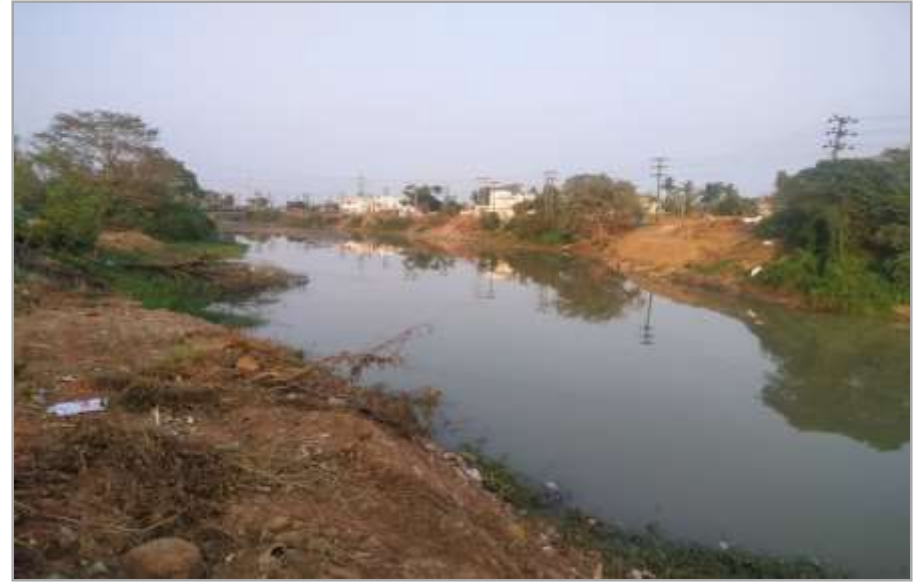
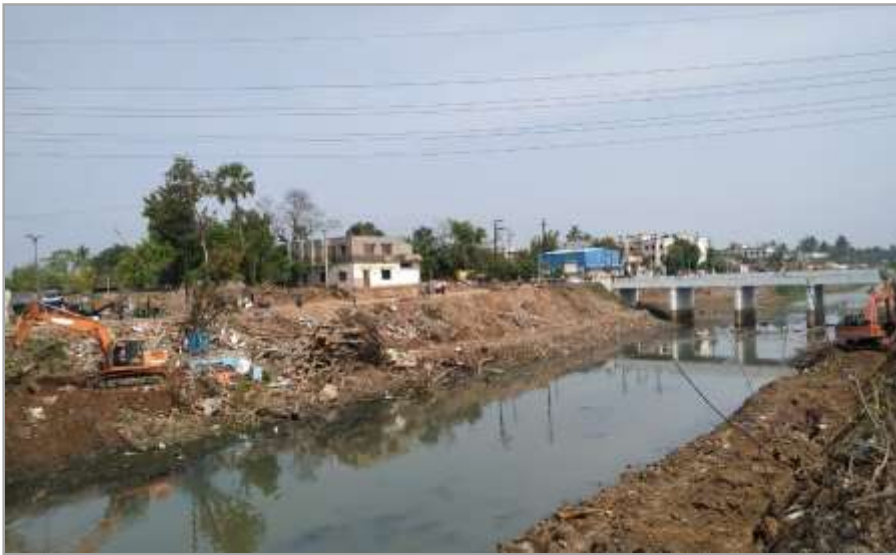
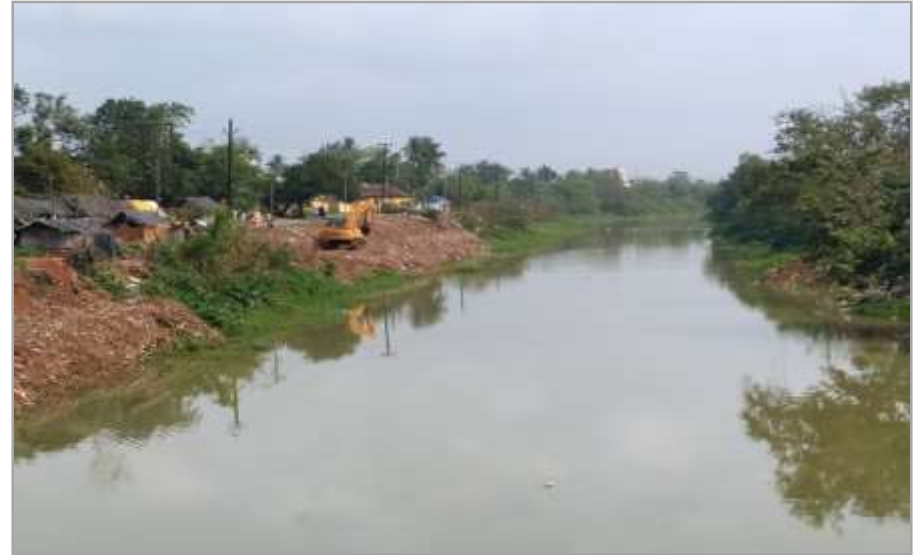
## View of Taladanda Canal before execution

**Growth of vegetation, shrubs along the slope & bed. The waterway filled with garbage presenting a very unpleasant, unhygienic and shabby look.**

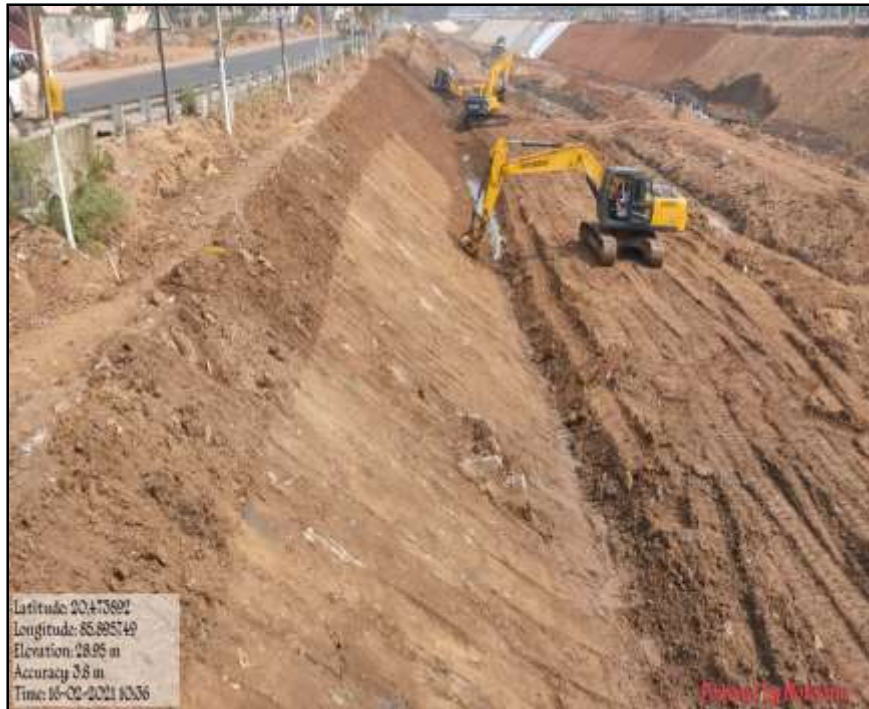
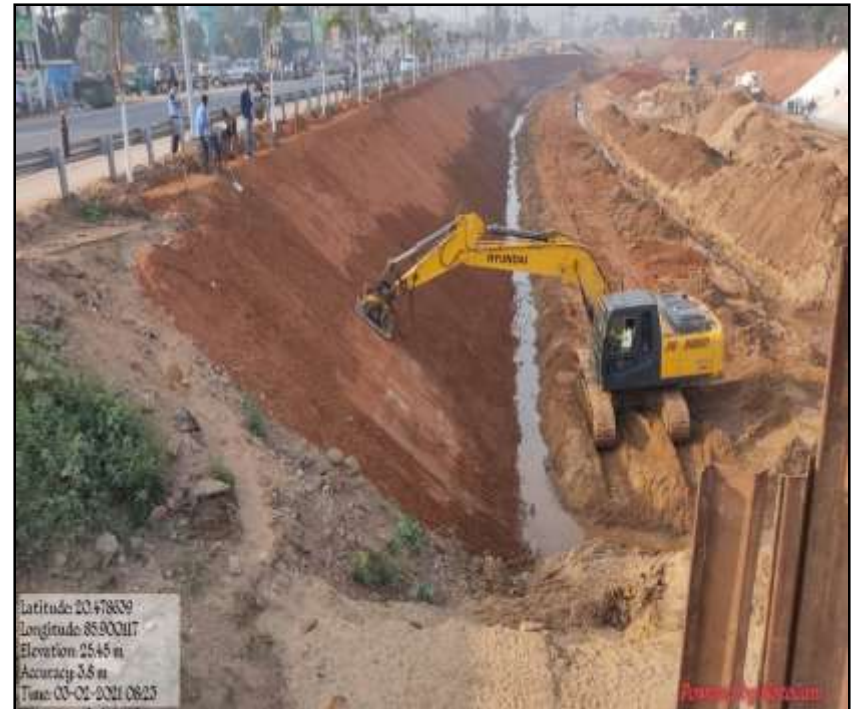
## Shaping the Slope profile

**Sand Filling followed by Moorum backing**

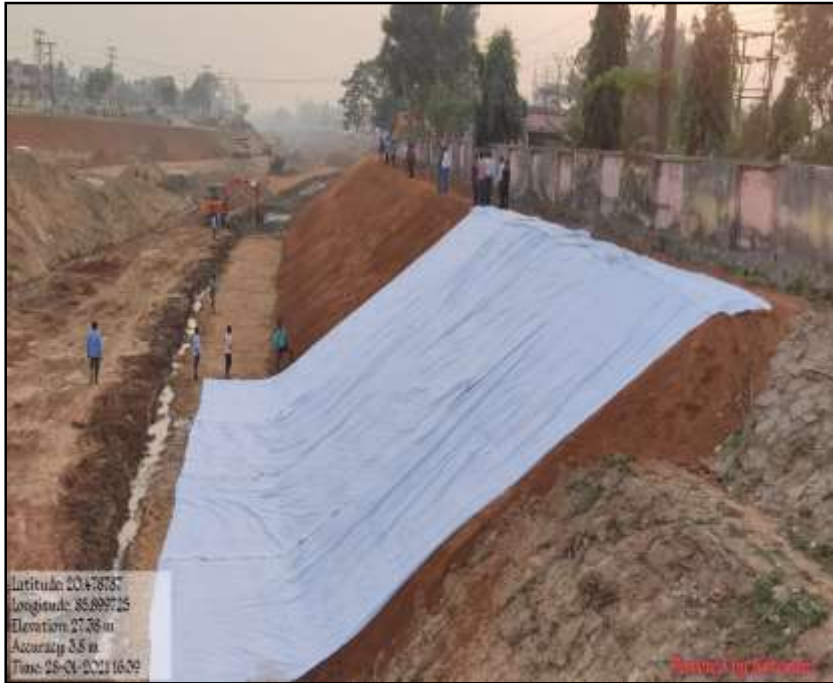
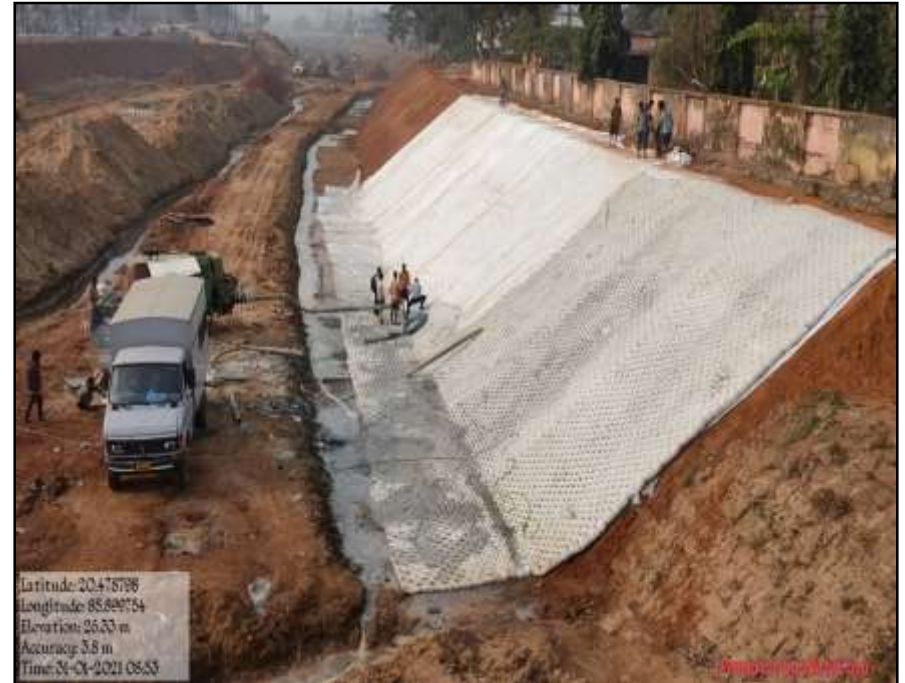
# Laying and Pouring of concrete into the CCGM

**Cementious Composite Lining Synthetic mattress (CCGM) over Synthetic mattress**

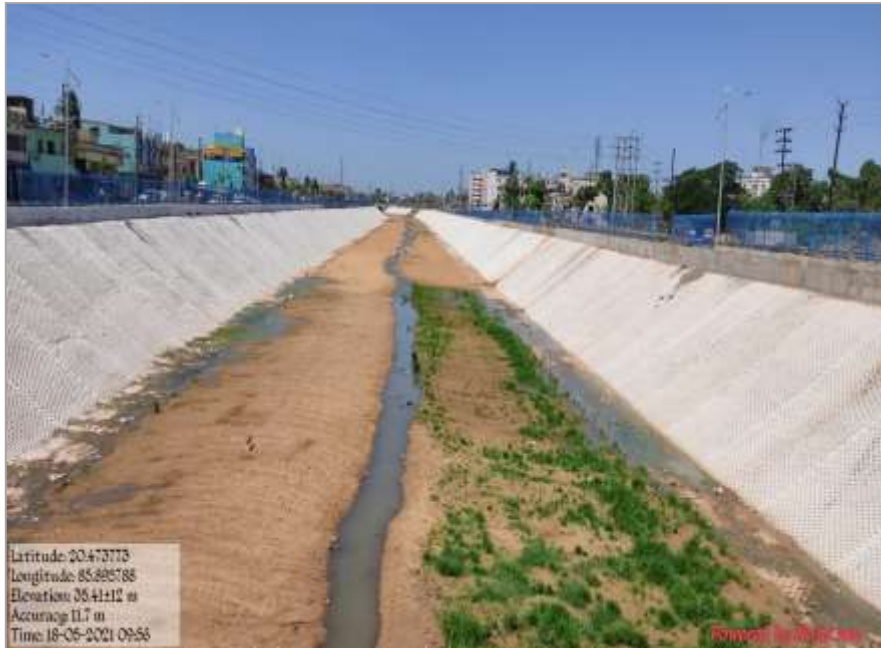
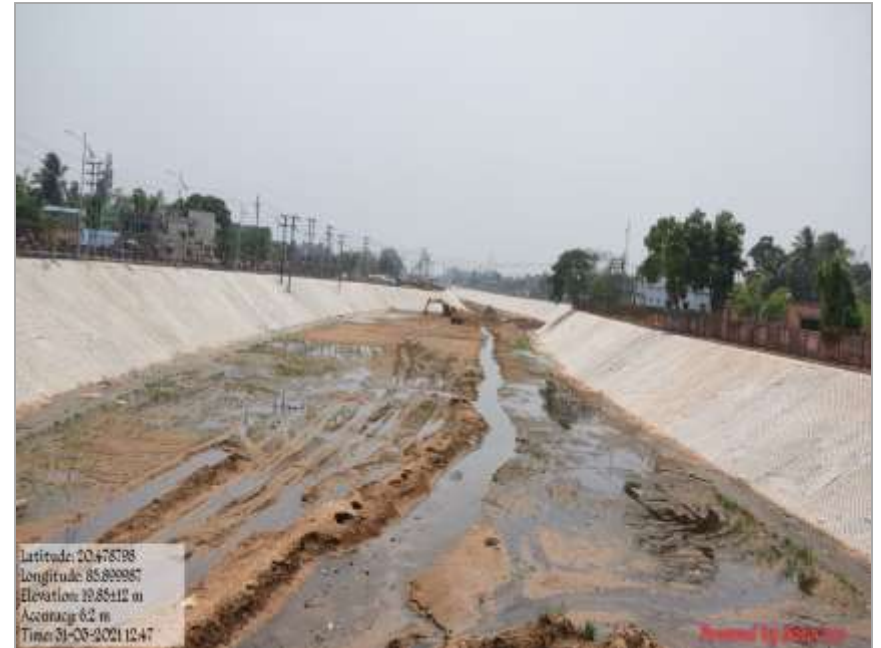
## View of CCGM complete

**The CCGM lining is ready for supply of water in canal**

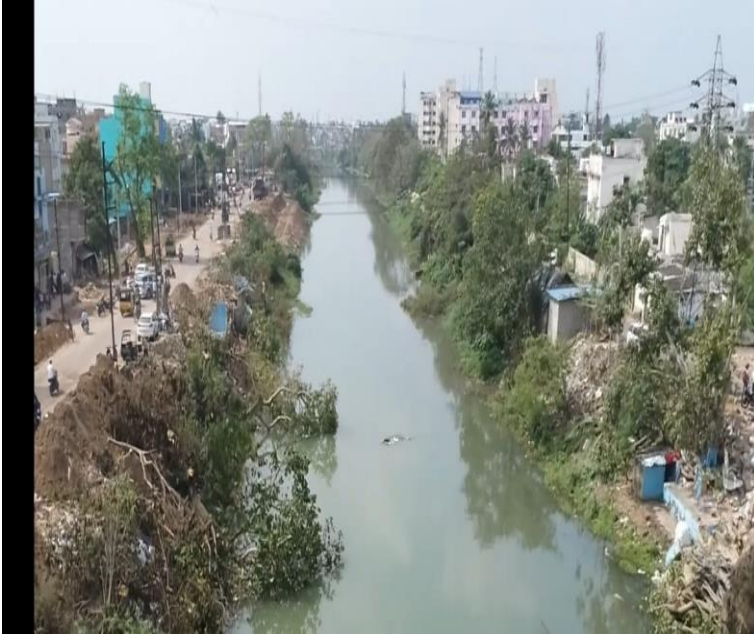
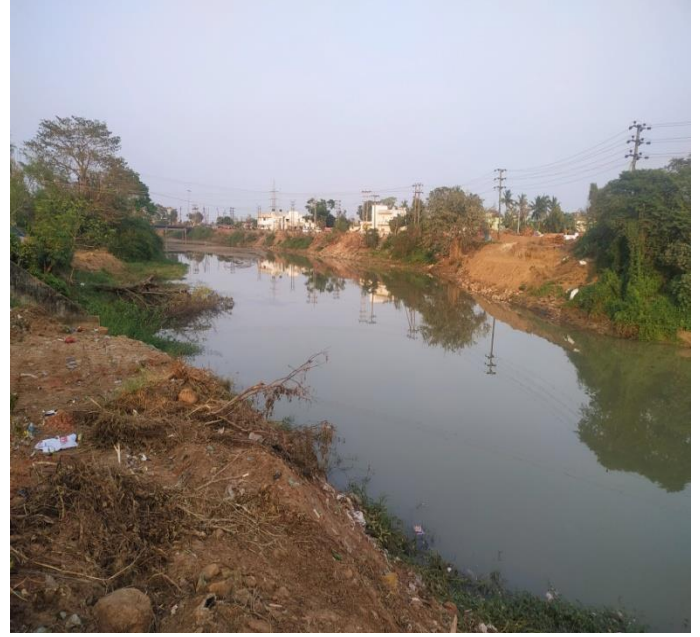
PRE-EXECUTION PHOTOGRAPHS

**Before execution Canal is looking more than a drain than a Canal. Presence lot of trees, shrubs, garbage on the canal slopes and bed making the canal scabby.**

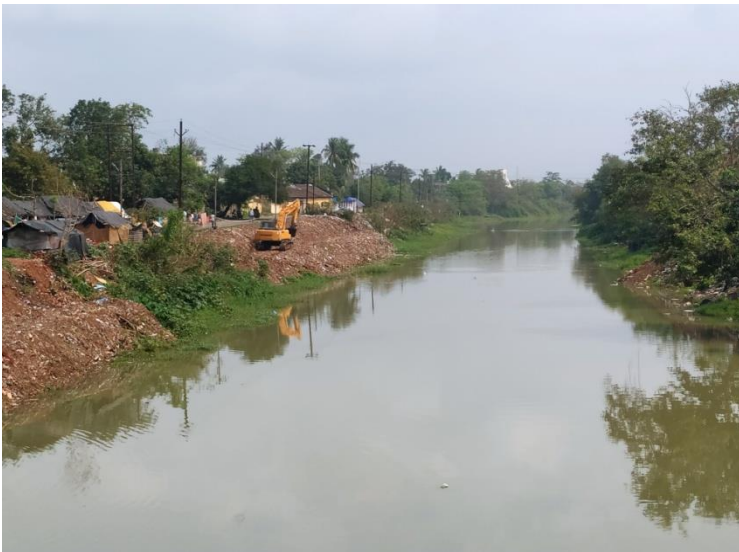
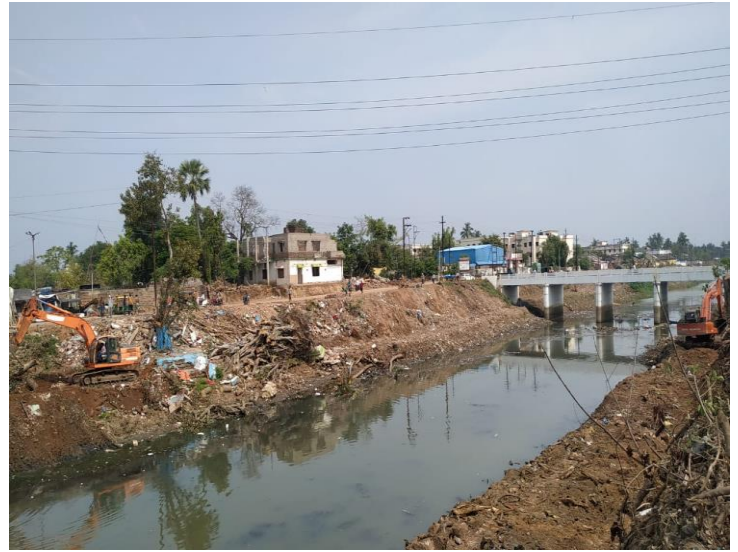
**Removing Debris, garbage, uprooting trees by means of excavators.**

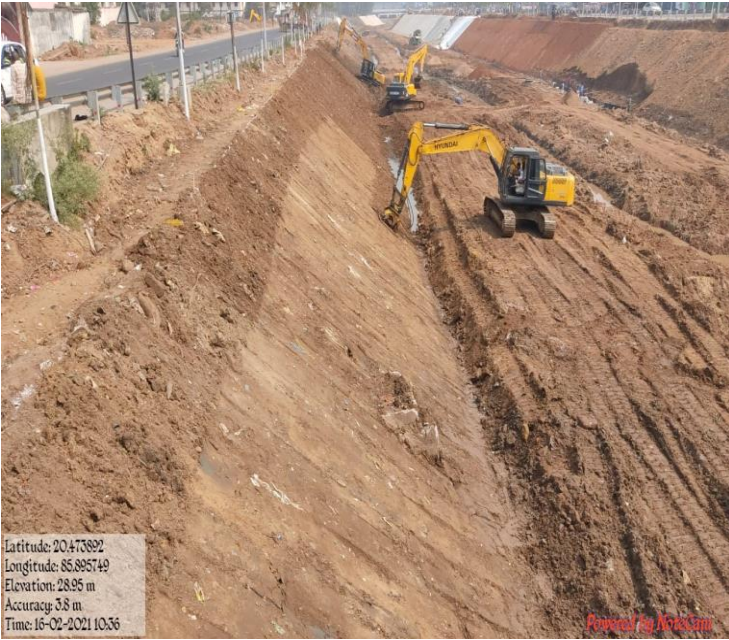
**Profiling the Canal Section**

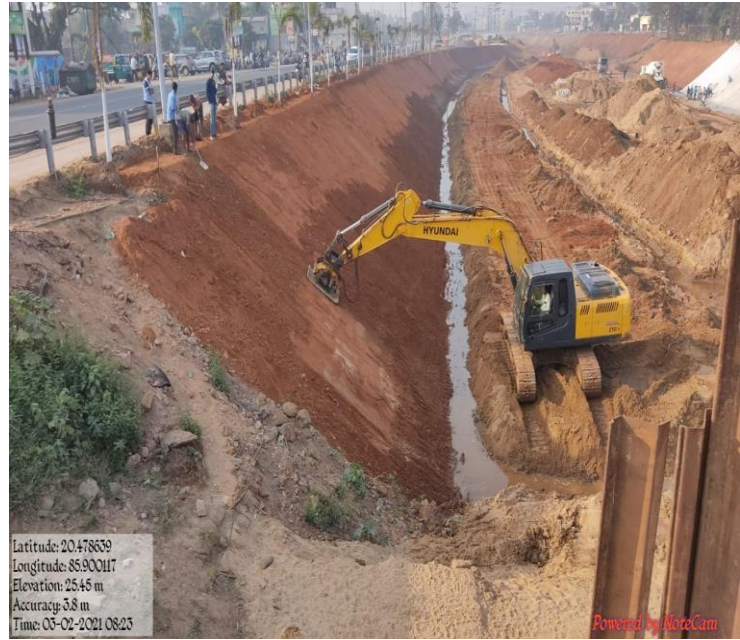
**Compaction using moorum admixture**

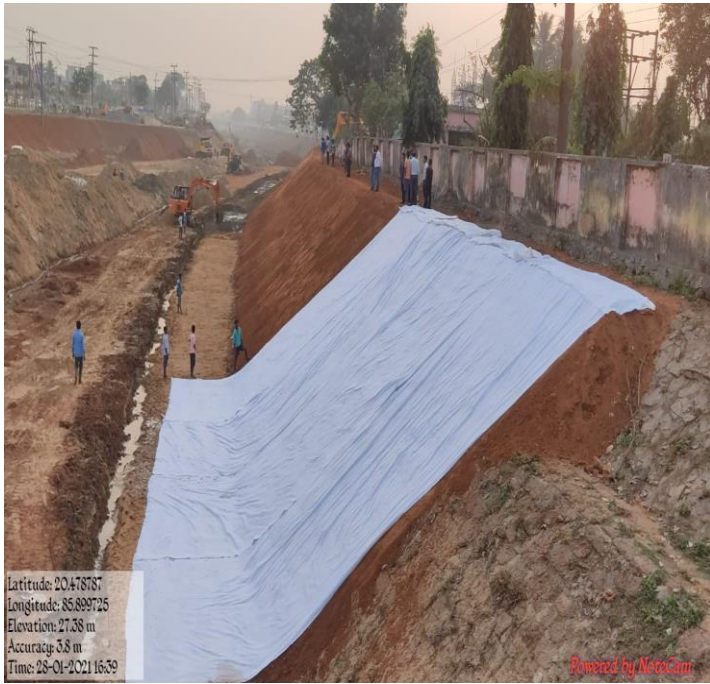
**Laying of Geo-textile synthetic mattress**

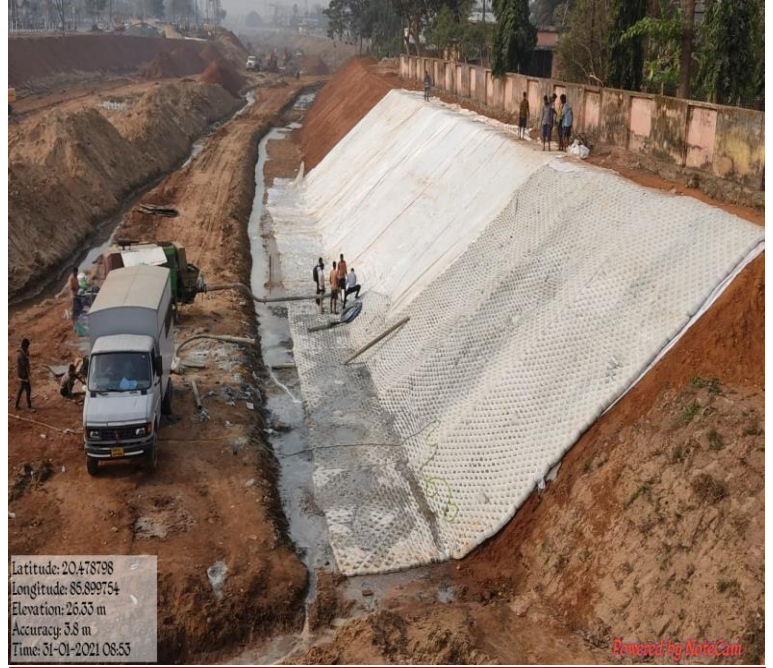
**Pouring of Concrete inside the Mattress.**

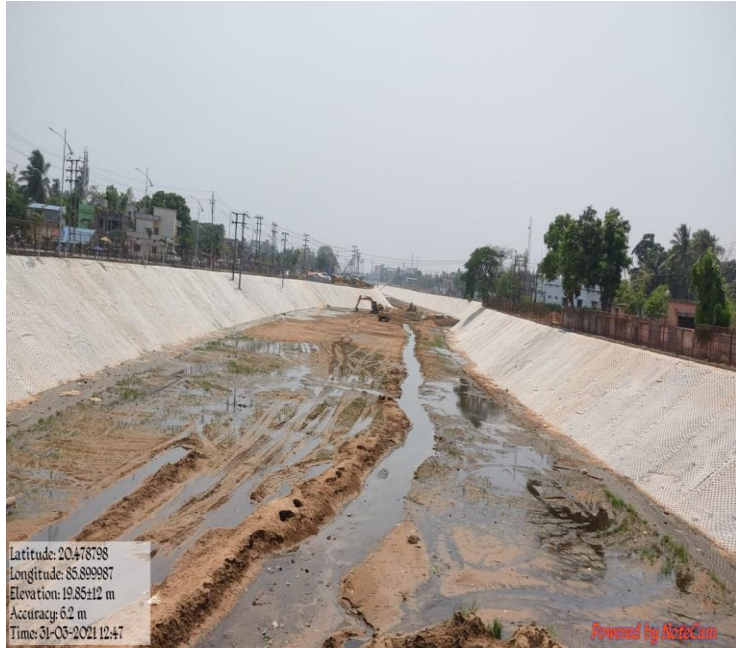
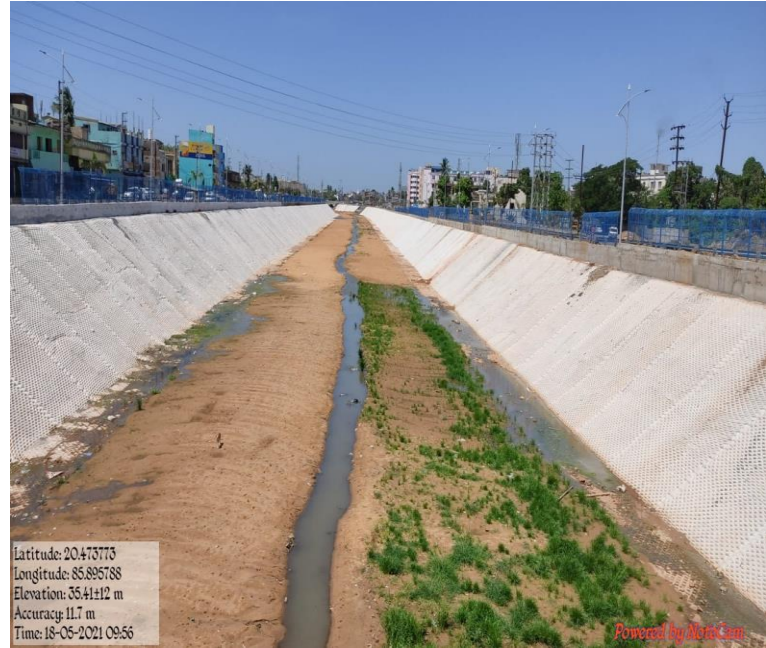
**(No water flow View)**

**Only Slope lining was done using CCGM technology and Canal bed was filled with sand.**

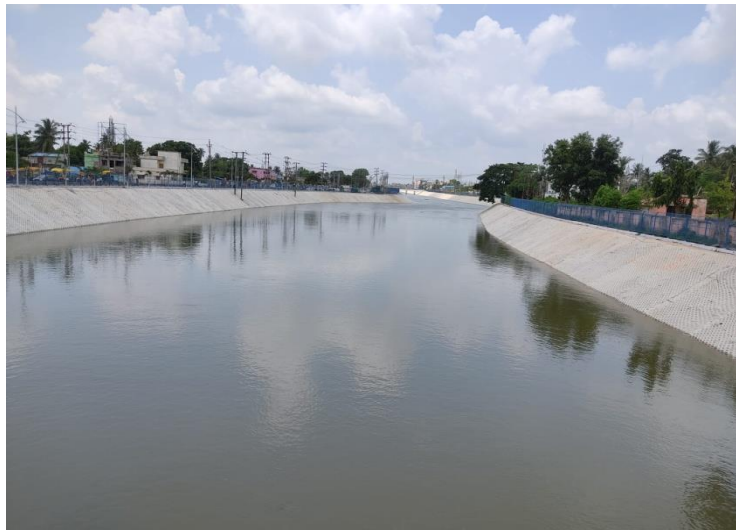
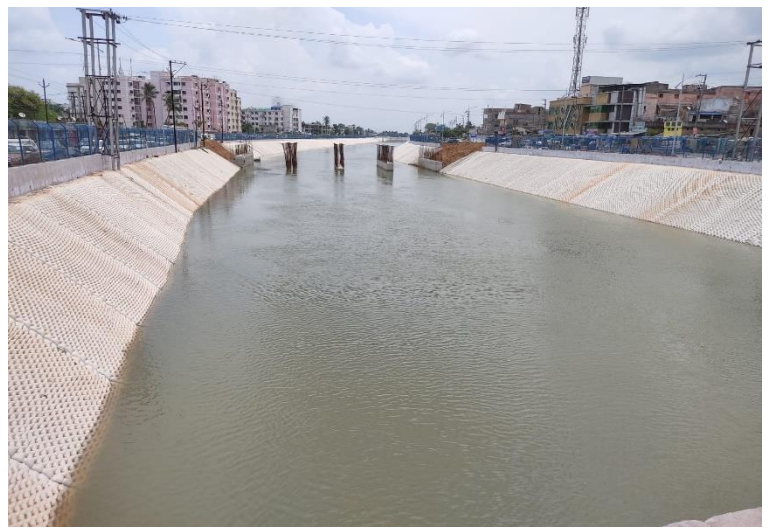
**View of Canal after Water Supply in Canals**
